MISSING DISPLAY OF SURROUND VIEW CAMERA

This Service Information bulletin replaces SI B66 17 17 **dated October 2017**

G12 (7 Series)	G30 (5 Series Sedan)	G01 (X3)	G32 (6 Series Gran Turismo)
----------------	----------------------	----------	-----------------------------

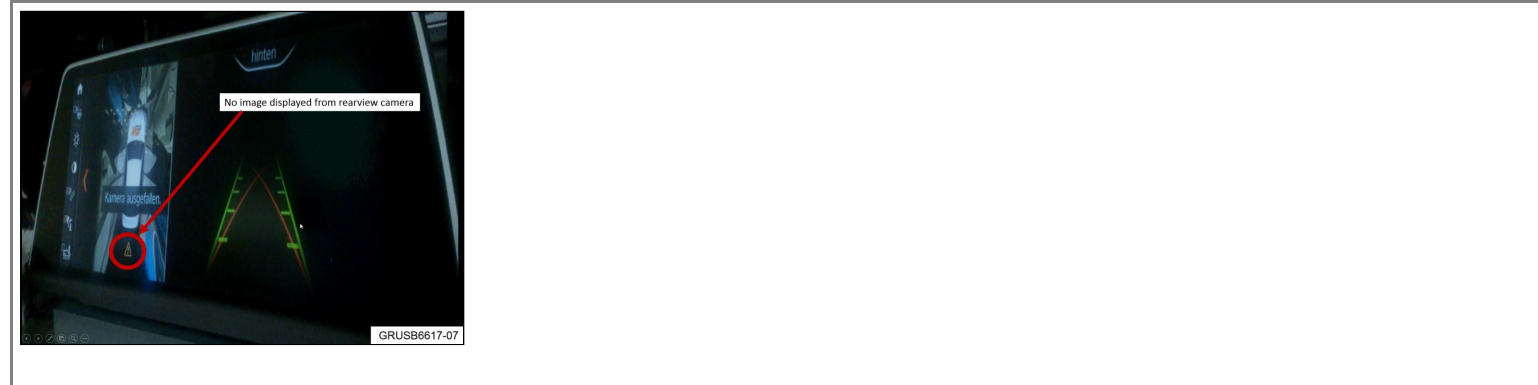
Central Information Display (CID) sporadically does not display Surround View Camera image.

The following fault memory entries are stored in the Surround View camera (ICAM2) control unit:

- 0x800ba5 Rear view camera: Internal camera fault
- 0x800b90 Rear view camera: max. permissible current exceeded

Software for the ICAM2 control unit.

Reprogram the vehicle with ISTA 4.08.24 or a more recent version.
