G01 (X3 Sports Activity Vehicle)	G02 (X4 Sports Activity Coupe)	G05 (X5 Sports Activity Vehicle)	G07 (X7 Sports Activity Vehicle)
G12 (7 Series Sedan)	G14 (8 Series Convertible)	G15 (8 Series Coupe)	G20 (3 Series Sedan)
G29 (Z4 Roadster)	G30 (5 Series Sedan)	G32 (6 Series Gran Turismo)

Produced with original Integration level 18-03-5xx.

- "0x804417 - Motion sensor (MEMS) in key: failure"

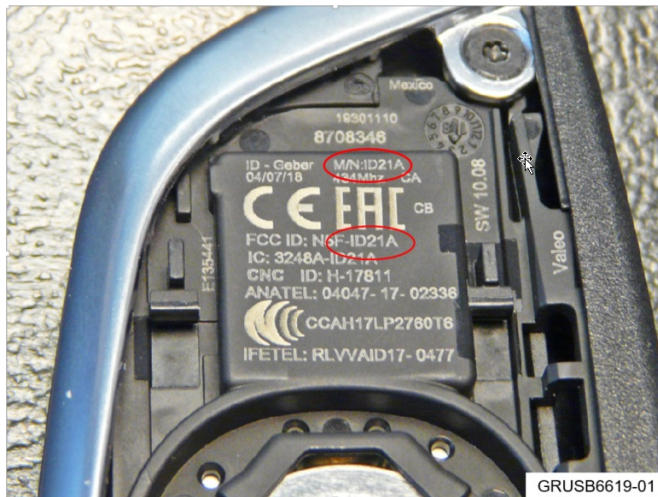
MEMS sensor in the remote key transmitter version 2.1.

Remote keys can be differentiated between version 2.1 and the earlier version 2 by removing the back cover.

Carefully check the ID printed in various places (circled). G05 basic remote key shown; other models similar.

The fault code can sometimes be created erroneously. In the case of a fault memory entry, it is not evident whether the fault is erroneous or actual.

- If the vehicle unlocked before the key was moved at Step 9, repeat the test.
 - If the vehicle can still be opened before the key was moved (at Step 9), it is likely that the MEMS in the key is faulty. Replace the remote key.
 - Refer to Repair Instructions 66 12... "Teach in radio remote control/radio remote control with display (BMW display key)"
1. If another remote key is available during this workshop session, repeat the test sequence to confirm proper MEM operation.
 2. Clear the fault code memory.
