LANE DEPARTURE WARNING (LDW): STEERING WHEEL VIBRATION NOT STRONG

This Service Information Bulletin (Revision 4) replaces SI B66 21 19 **dated January 2021**.

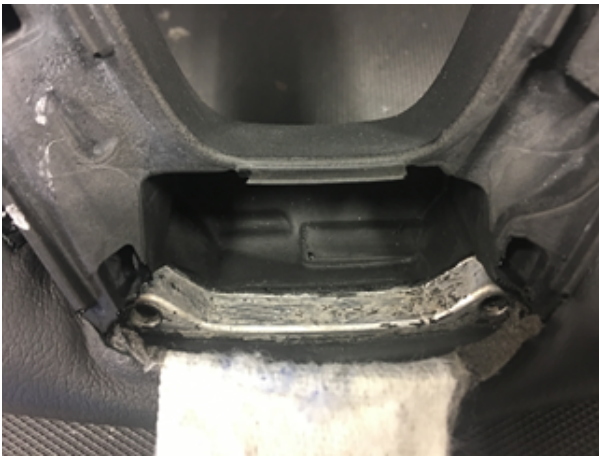
10. This image shows the rubber material coating on the steering wheel removed where the vibration actuator is mounted.

- Perform a software update dependent on the current integration level (I-level)
- Perform Test Plan AT6131_BDC11LRE,
and /or
o Remove actuator insulation
- Replace the vibration generator

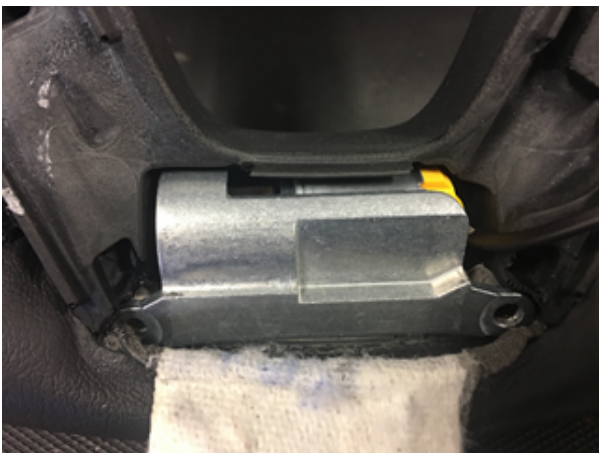
11. Image shows the vibration actuator with the insulation removed.
