## TOP VIEW CAMERA: IMAGE IS MISALIGNED

This Service Information Bulletin (Revision 4) replaces SI B66 29 19 **dated March 2021**.

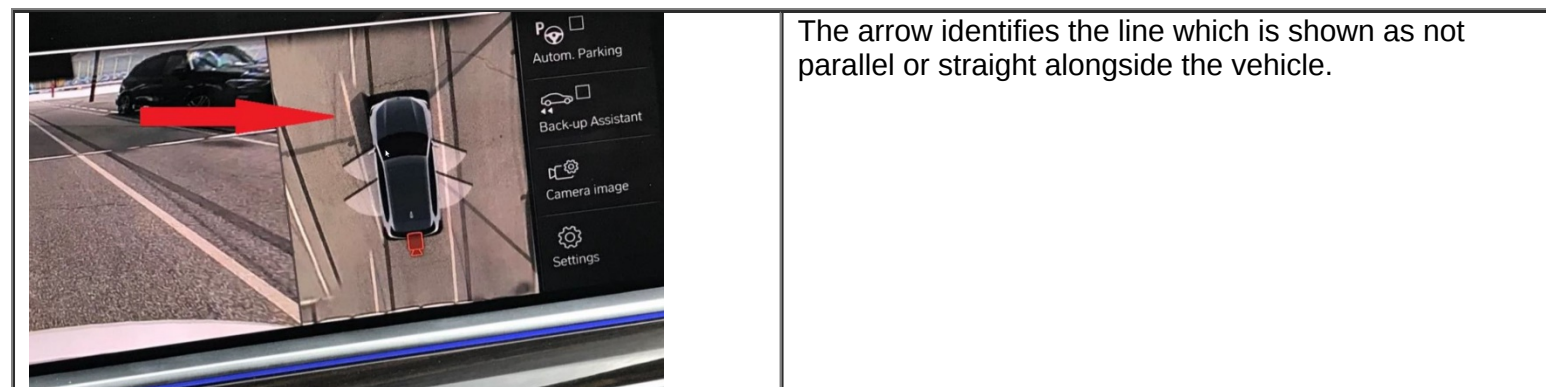
The top view image of the vehicle is misaligned when observed in the Control Information Display (CID). When the vehicle is parked in a parking spot with line markings, it is clearly noticed in the CID that the lines are not parallel to the side of the vehicle. This may be noticed on either the driver side, passenger side or both.

The arrow identifies the line which is shown as not parallel or straight alongside the vehicle.

Side view camera loose fitment in the exterior mirror bracket, causing changes to the top view image.

Reposition the camera in the exterior side view mirror with felt tape and / or software update with ISTA 4.26.3x or higher. Target Integration level (I-level) of S15A/S18A-20-11-500 or higher.
