**What's New:**

**Model**

G05 (X5 Sports Activity Vehicle)	G07 (X7 SAV)	G14 (8 Series Convertible)	G15 (8 Series Coupe)
G20 (3 Series Sedan)	G29 (Z4 Roadster)

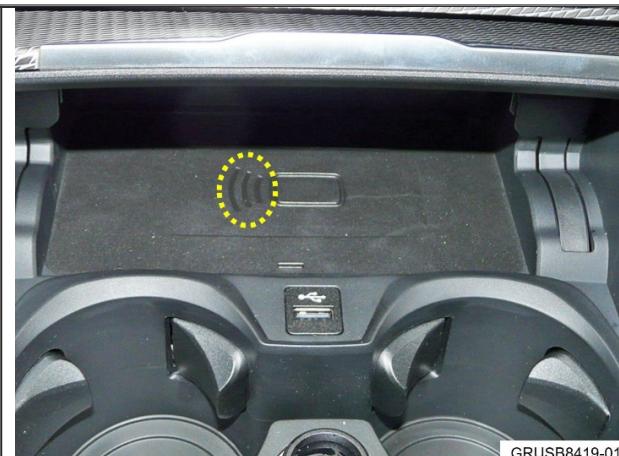
**NFC only; no wireless charging.**

- NFC is indicated by the 3 curved lines (circled) to the left of the cell phone outline

G20 shown; other models similar.

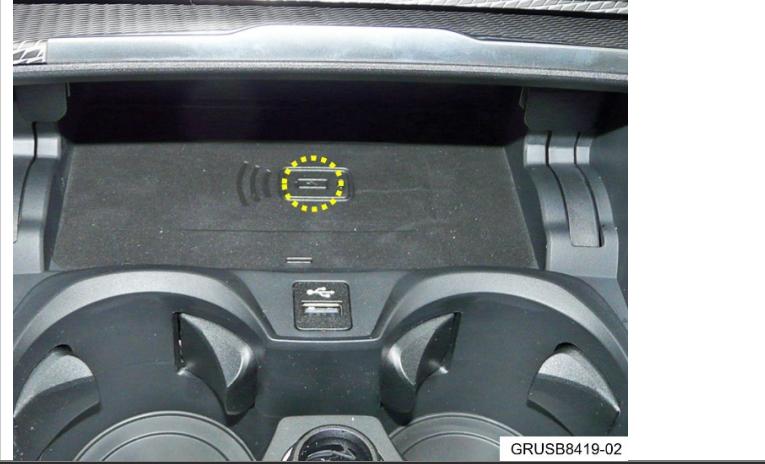
**NFC and wireless charging.**

- Wireless charging capability is indicated by the "lightning bolt" icon (circled) within the cell phone outline
