This Service Information bulletin replaces SI B00 03 17 **dated April 2018**

MODEL

F15 (X5, except M)	F16 (X6, except M)	F26 (X4)	F39 (X2)
F48 (X1)	F85 (X5 M)	F86 (X6 M)	G01 (X3)

UPDATE! F39, F48: As of 7/2018 vehicle production, the following changes can be noticed during QC1:

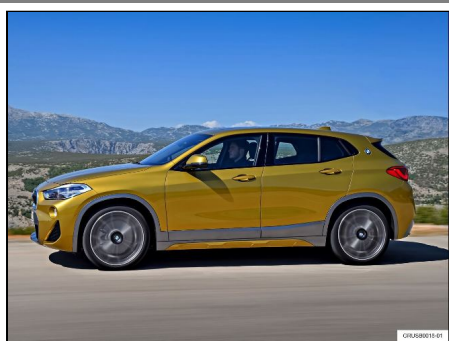
X2 (F39)

This newest Sports Activity Coupe combines the traditional lower roofline of a coupe with the robust construction of a BMW X model.

The X2 is built at BMW’s Plant Regensburg, Germany. For more information on this model, refer to either:

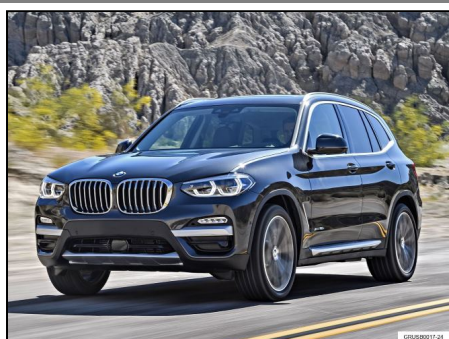
X3 (G01):

BMW presents the 3rd generation X3 Sports Activity Vehicle (G01), successor to the previous F25.

The G01 incorporates many new features, such as:

- Active kidney grills
- Hexagonally-shaped headlamps

- Light cascades for entry illumination of the entire sides of the vehicle, located at the front of the rocker panels
- Dual exhaust pipes, with the pipes exiting near the outer ends of the bumper
- Standard equipment sport seats
- iDrive 6.0 with 10.25" touch-screen Central Information Display (CID)
- 3-zone automatic climate control, with separate temperature controls for the rear compartment
- Adjustable rake on the rear seat backrest
- First M Performance model in the X3 range
- Optional factory-installed trailer hitch
