This Service Information Bulletin (Revision 3) replaces SI B00 03 18 **dated December 2018**.

E-Series	Model Description
I01	i3
I12	i8 Coupe
I15	i8 Roadster

### New product information

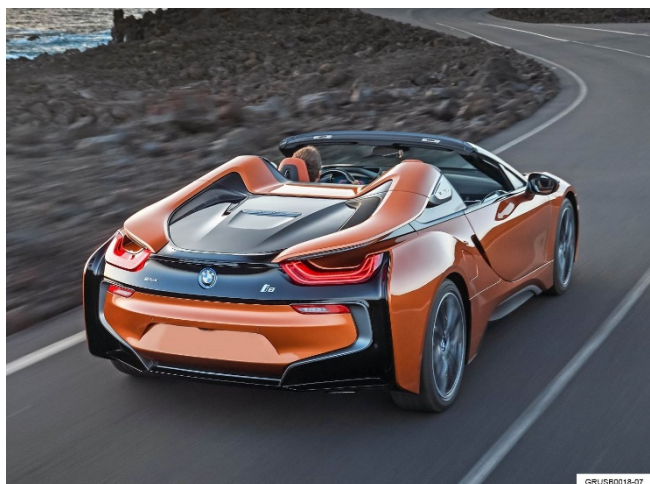
- Front axle electric motor power output increased 12 bHp to 141 bHp; drivetrain combined power rated at 369 bHp and 420 lb. ft. torque
- Redesigned hood with smaller air exit vents

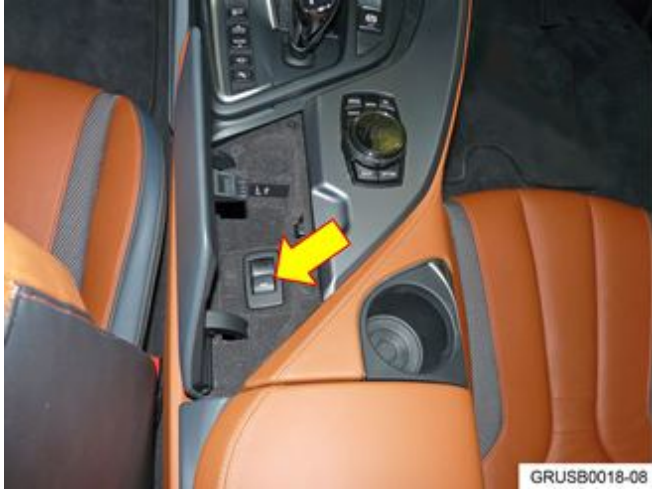
Opening and closing the top from inside the vehicle-

The convertible top switch (arrow) is located in the center console bin.

Opening the top:

- Push and hold the switch down
- The door windows partially lower, and the convertible top opens
- The rear window is partially opened
- Once the convertible top storage cover closes and locks, release the switch
- A check control message indicates a completed top movement

Closing:

- Pull and hold the switch up
- The windows are partially lowered, the convertible top is closed, then the windows are raised
- After the top is latched to the windshield header, release the switch
- A check control message indicates a completed top movement

The convertible top movement is interrupted if the switch is released or a door is opened. The sequence can be continued in the desired direction using the switch. The convertible top and the convertible top storage cover are not locked in this case. Operate the switch again until the top movement is completed.
