This Service Information bulletin supersedes SI 16 14 14 dated November 2014.

I12 (i8)

A Recall Campaign has been issued on certain Model Year 2014 I12 (i8) vehicles produced from May 16, 2014 through September 16, 2014. The bolt for attaching a ground cable at the bottom of the fuel tank may not be welded correctly, which could result in a fuel leak.

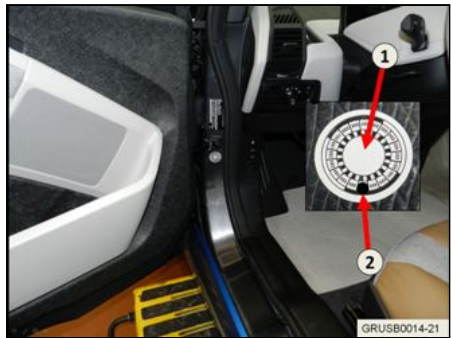
LABEL INSTRUCTIONS

<p>This Service Action has been assigned code number 715. After the vehicle has been checked and/or corrected, obtain a label (SD 92-453) and:</p> <ol style="list-style-type: none"> Emboss your BMW center warranty number in the middle of the label (1); Punch out code number 715 (2), printed on the label; and Affix the label to the A-pillar as shown.
--	--

If the vehicle already has a label from a previous Service Action/Recall Campaign, affix the new label next to the old one. Do not affix one label on top of another one because a number from an underlying label could appear in the punched-out hole of the new label.
