**MODEL**

SITUATION

During inspection and/or diagnosis there is noticeable dirt/grease buildup on the axles near the inner and/or outer CV boots.

Inspecting the axle CV boots-

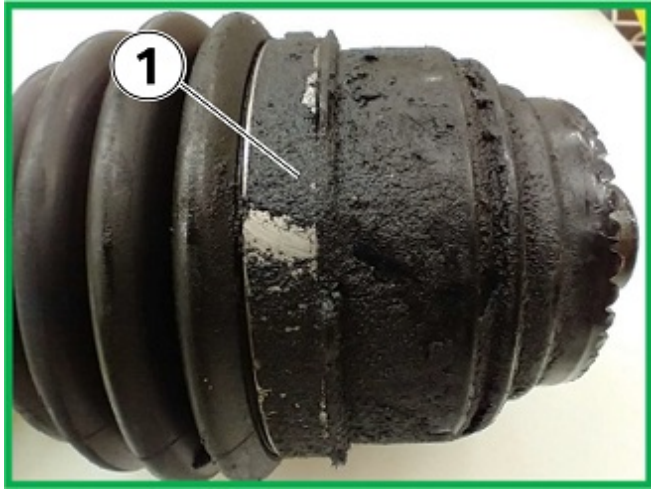
Example of dirt/contamination from outside influence (1).

Surface contamination and/or grease build-up is normal. Do not replace the CV boot (inner) or axle half-shaft (outer).

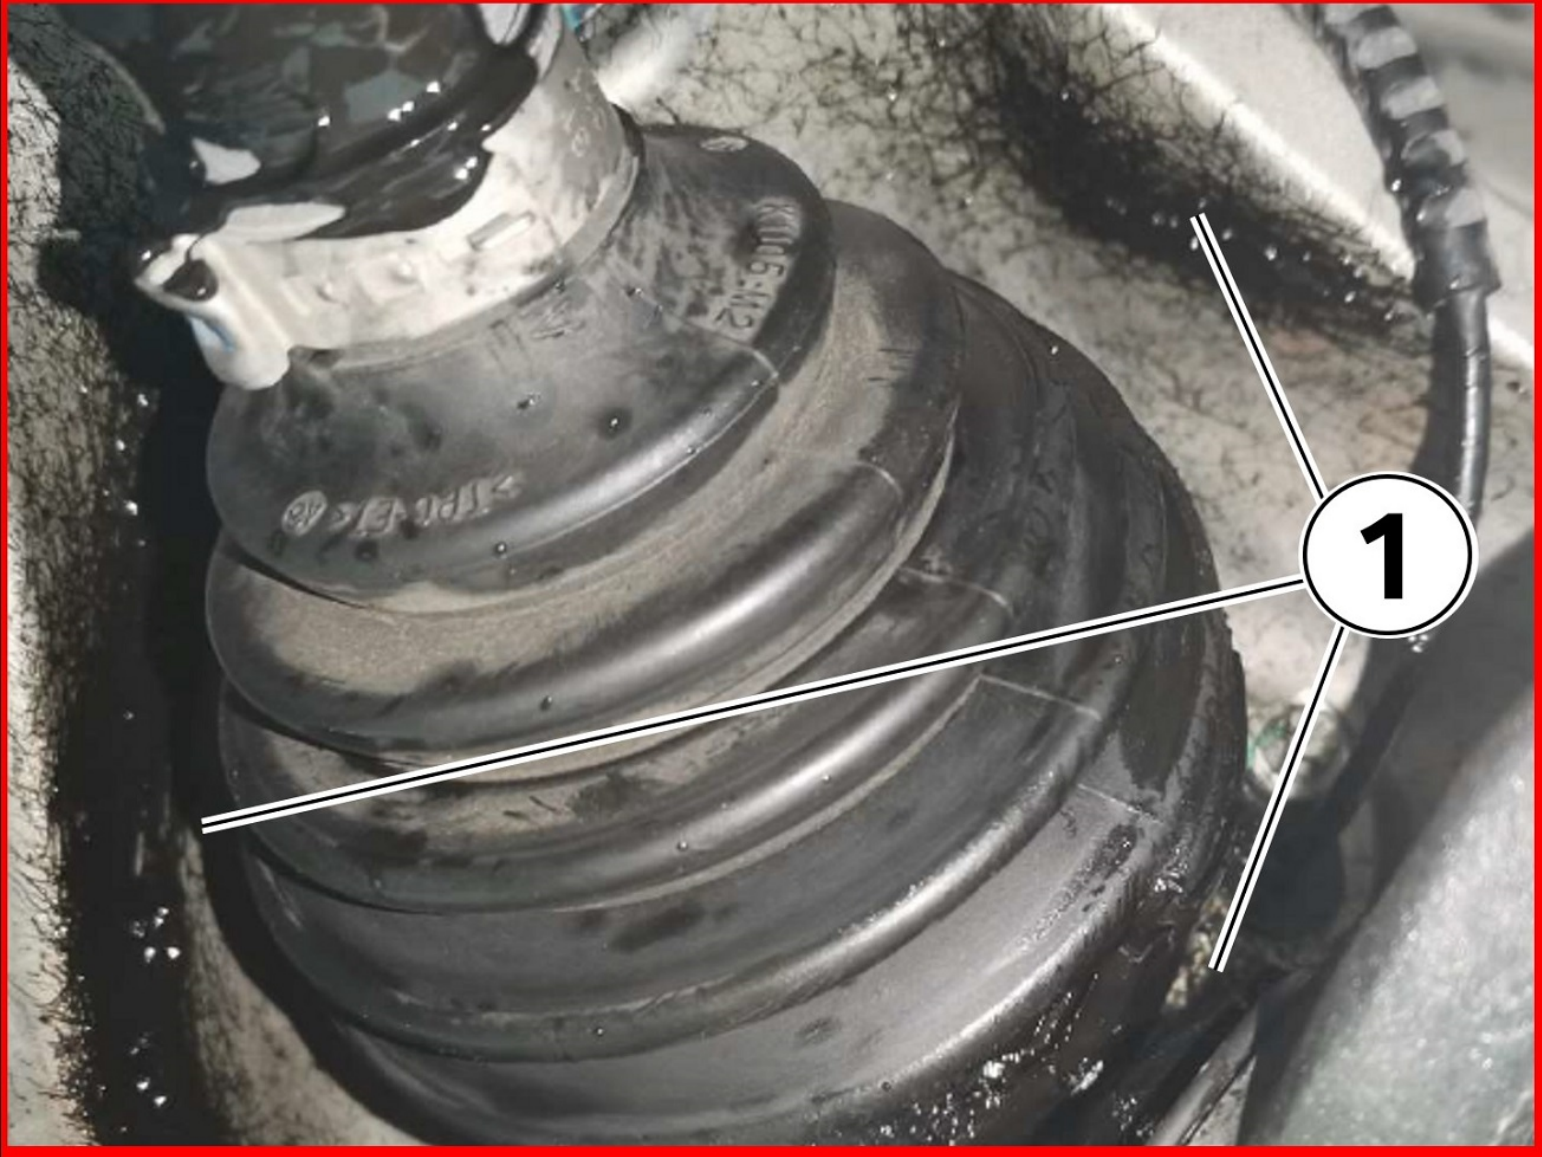
The below example is a boot that is dispersing grease around the outer carrier (1).

Only replace a CV boot (inner) or axle half-shaft (outer) under the following circumstances:

- There is a crack or tear in the CV boot
- There is a clamp missing from the CV boot
- The clamps can be easily moved/rotated (outside boot)
- There is visible grease slinging onto the components around the CV joint rotation area
