**MODEL**F30 Produced from October 18, 2011 **with** option code SA760 (high-gloss shadow line)**SITUATION**

A grating noise may occur in the area of the mirror triangle when the door is opened or closed.

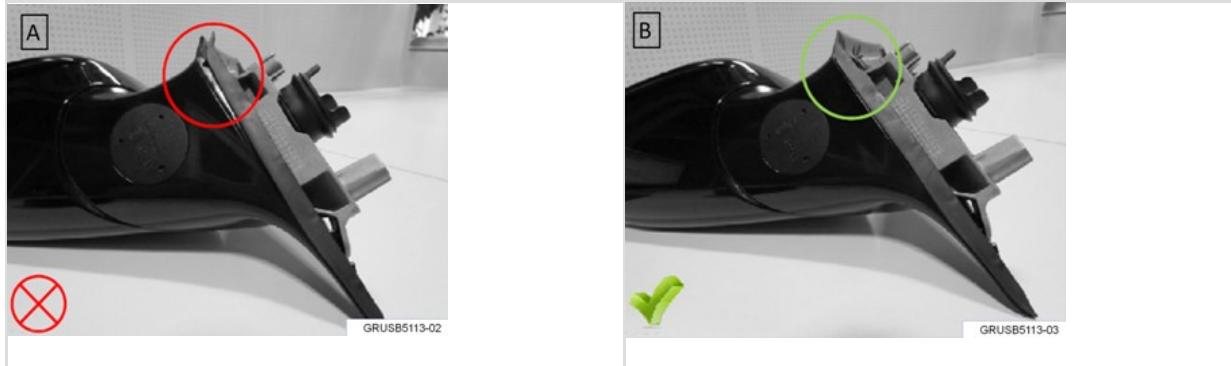
The door mirror triangle fitment to the mirror recessed cover

1. Confirm the noise is coming from the mirror triangle seal by opening and closing the front door several times.
2. Refer to ISTA Repair Instruction 51 16 000, "Remove and refit/replace door mirror on left or right front door."
3. The triangle sealing lip is not fully formed over the mirror housing, as shown in picture A.
4. Re-fit the sealing lip as shown in picture B.
5. Reinstall the removed parts in the reverse order of their removal.
6. Open and close the door several times to confirm the noise has been eliminated.
