E-Series	Model Description	Production Date
F48	X1 Sports Activity Vehicle	Up to December 7, 2020
G01	X3 Sports Activity Vehicle	Up to December 7, 2020
G02	X4 Sports Activity Coupe	Up to December 7, 2020

Streaks are found running mostly vertically down along the door outer skin from the lower window trim. This can affect any of the 4 side doors.

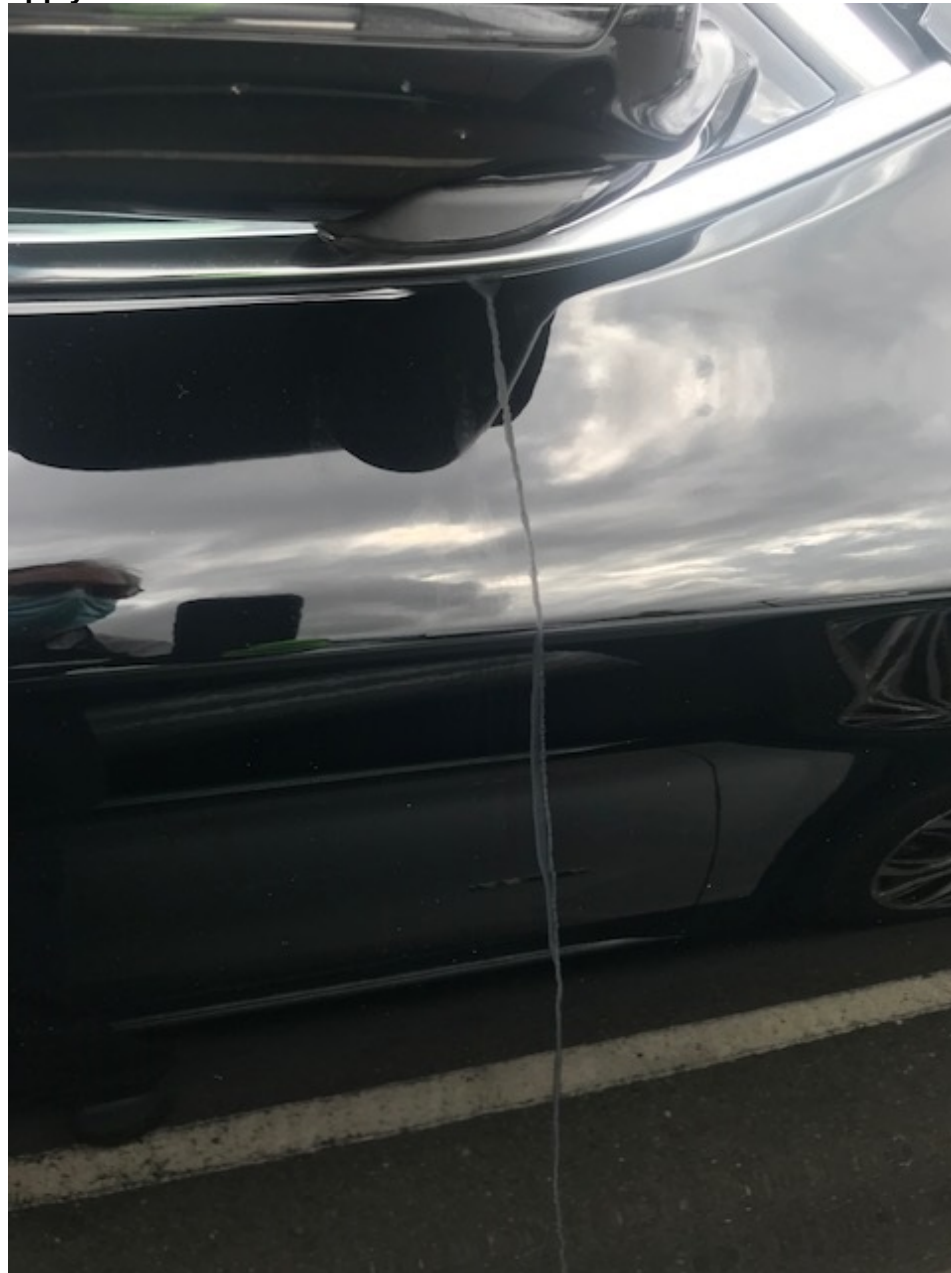
**Note: The door streaks outlined in this bulletin are NOT the result of normal water droplets. The streaks will appear as a consistent streak down the door and may feel waxy and will be challenging to clean.**

Insufficient protective coating of the aluminum door trim causes oxidation to form and trail down the door skin.

Replace the affected door trim and clean the paint using an alcohol-based cleaner which is safe for vehicle paint. Paint correction may be required if the streaks cannot be removed from the vehicle clearcoat.

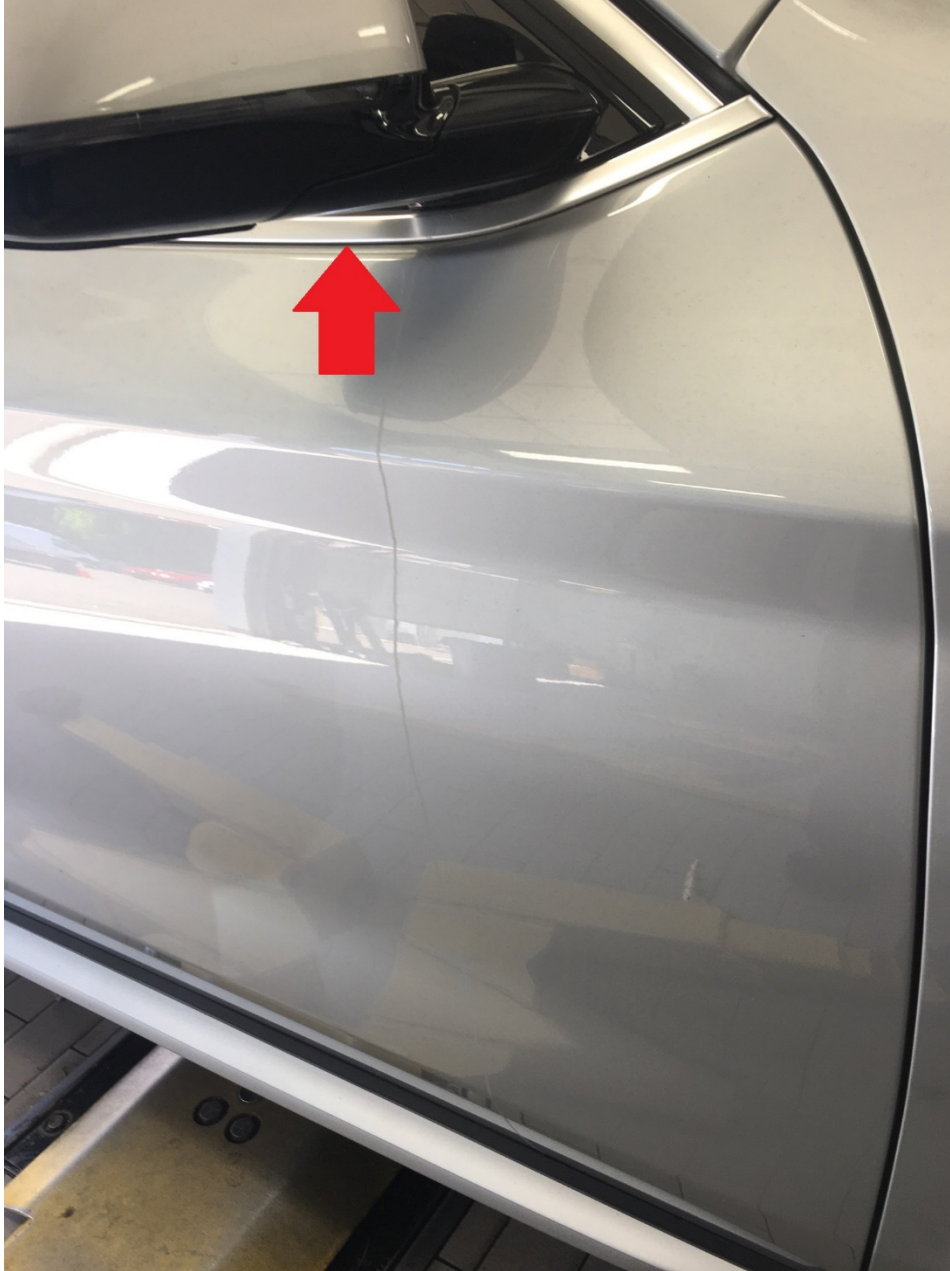
1. Replace the shaft cover (window molding) on the affected door following ISTA repair instructions for the applicable model and trim being replaced. A photo is shown below demonstrating which trim is to be replaced. A driver's door shaft cover is being shown as an example, but any of the 4 doors can be affected.

2. Clean the streaks on the door paint using an alcohol-based cleaner which is safe for vehicle paint, such as R2 cleaner P/N 83 19 0 417 324. If the streaks cannot be cleaned from the vehicle paint, the vehicle may require paint correction.
