LIN BUS FAULTS WITH EXTERIOR REARVIEW MIRROR GLASS DAMAGE

This Service Information Bulletin (Revision 7) replaces SI B51 13 18 dated February 2021.

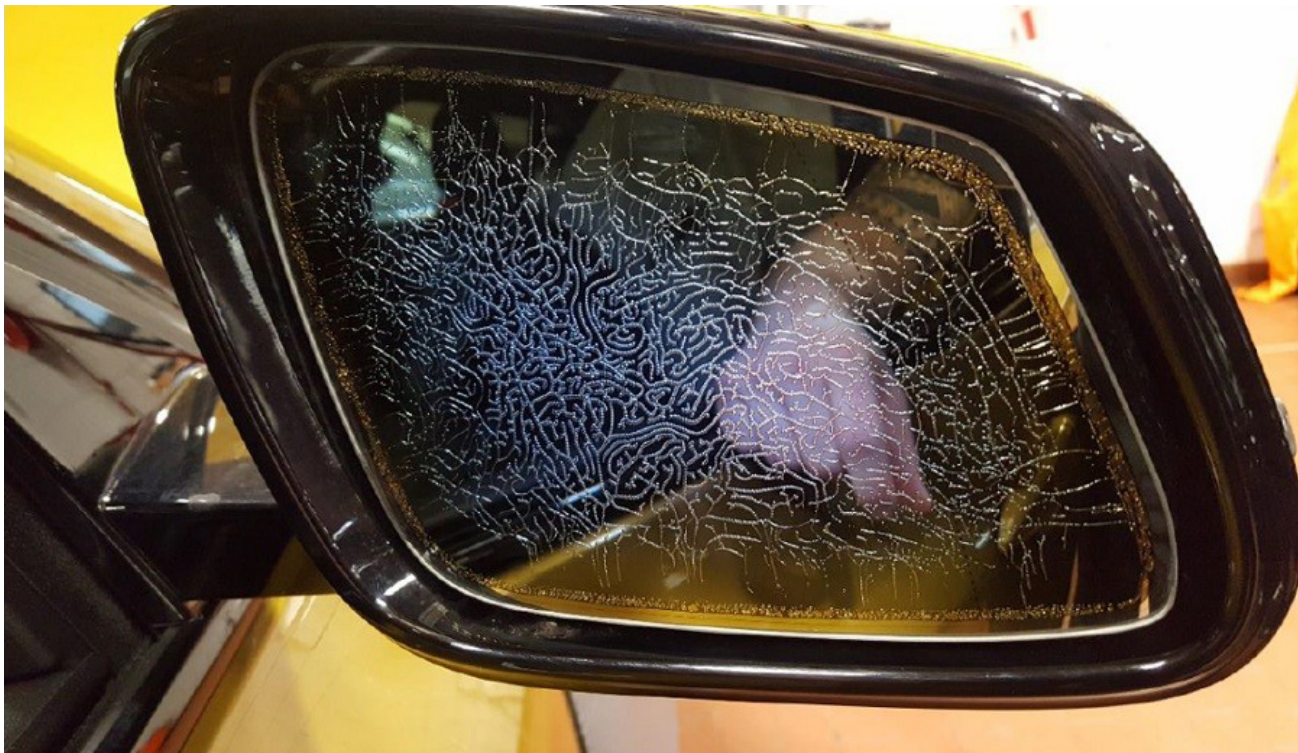
- The exterior rearview mirror glass is discolored or cracked
- The power windows and folding mirrors may not operate
- One or more of the following LIN bus faults are stored in the BDC (Body Domain Controller):

Faulty exterior rearview mirror electronics have created a short on the LIN bus, damaging the mirror glass and causing functional errors in power window and exterior mirror operation.

Replace the mirror electronics in the exterior mirror.

1. Test the operation of the power windows, side rearview mirror adjustment, and side rearview mirror folding functions. Inspect the side rearview mirror glass on both sides for damage as shown in the photo above.

3. Replace the mirror electronics of the affected mirror following repair instructions **REP 67 13 526 “Replacing mirror electronics for electrically adjustable exterior mirror left or right”**.

4. Replace the mirror glass, if damaged.
