E-Series	Model Description	Production Date	Affected Option Code
G01	X3 Sports Activity Vehicle	Vehicles produced up to May 3 2021	Vehicles with standard equipment and optional equipment SA488 Lumbar support Driver/Passenger
G02	X4 Sports Activity Coupe		
G20	3 Series Sedan		
G22	4 Series Coupe		
G23	4 Series Convertible		
G26	4 Series M Coupe

SITUATION

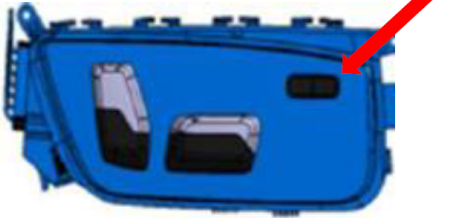
The customer may notice that there are blank plugs on the seat adjustment cover plate. This may be found on the driver and passenger side. The plug may not match in color and/or surface finish.

<p>If the customer has a concern about this issue (for example, the color and/or surface finish difference of the blank plugs), replace the seat adjustment front seat control unit.</p> <p>The replacement part does not have any blank plugs</p>
---	---

Follow ISTA Repair Instructions **REP 61 31 204** Replacing operating unit for seat adjustment.

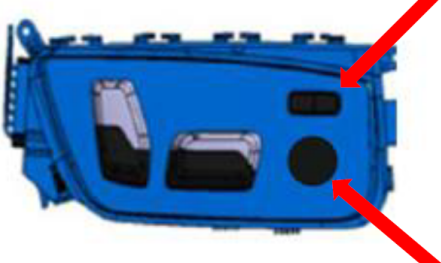
There may be one or two plugs.

Due to a production adjustment at the vehicle plant, the control unit seat adjustment front seat is equipped with a blank plug. This was eliminated in vehicles as of May 3, 2021 production.
