This Service Information Bulletin (Revision 2) replaces SI B63 03 18 dated February 2019.

G01 (X3 Sports Activity Vehicle)	G02 (X4 Sports Activity Coupe)	G05 (X5 Sports Activity Vehicle)	G06 (X6 Sports Activity Coupe)
G07 (X7 Sports Activity Vehicle)	G12 (7 Series Sedan)	G20 (3 Series Sedan)	G22 (4 Series Coupe)
G23 (4 Series Convertible)	G32 (640i xDrive Gran Turismo)

The light carpet may appear dim or distorted on one or both sides.

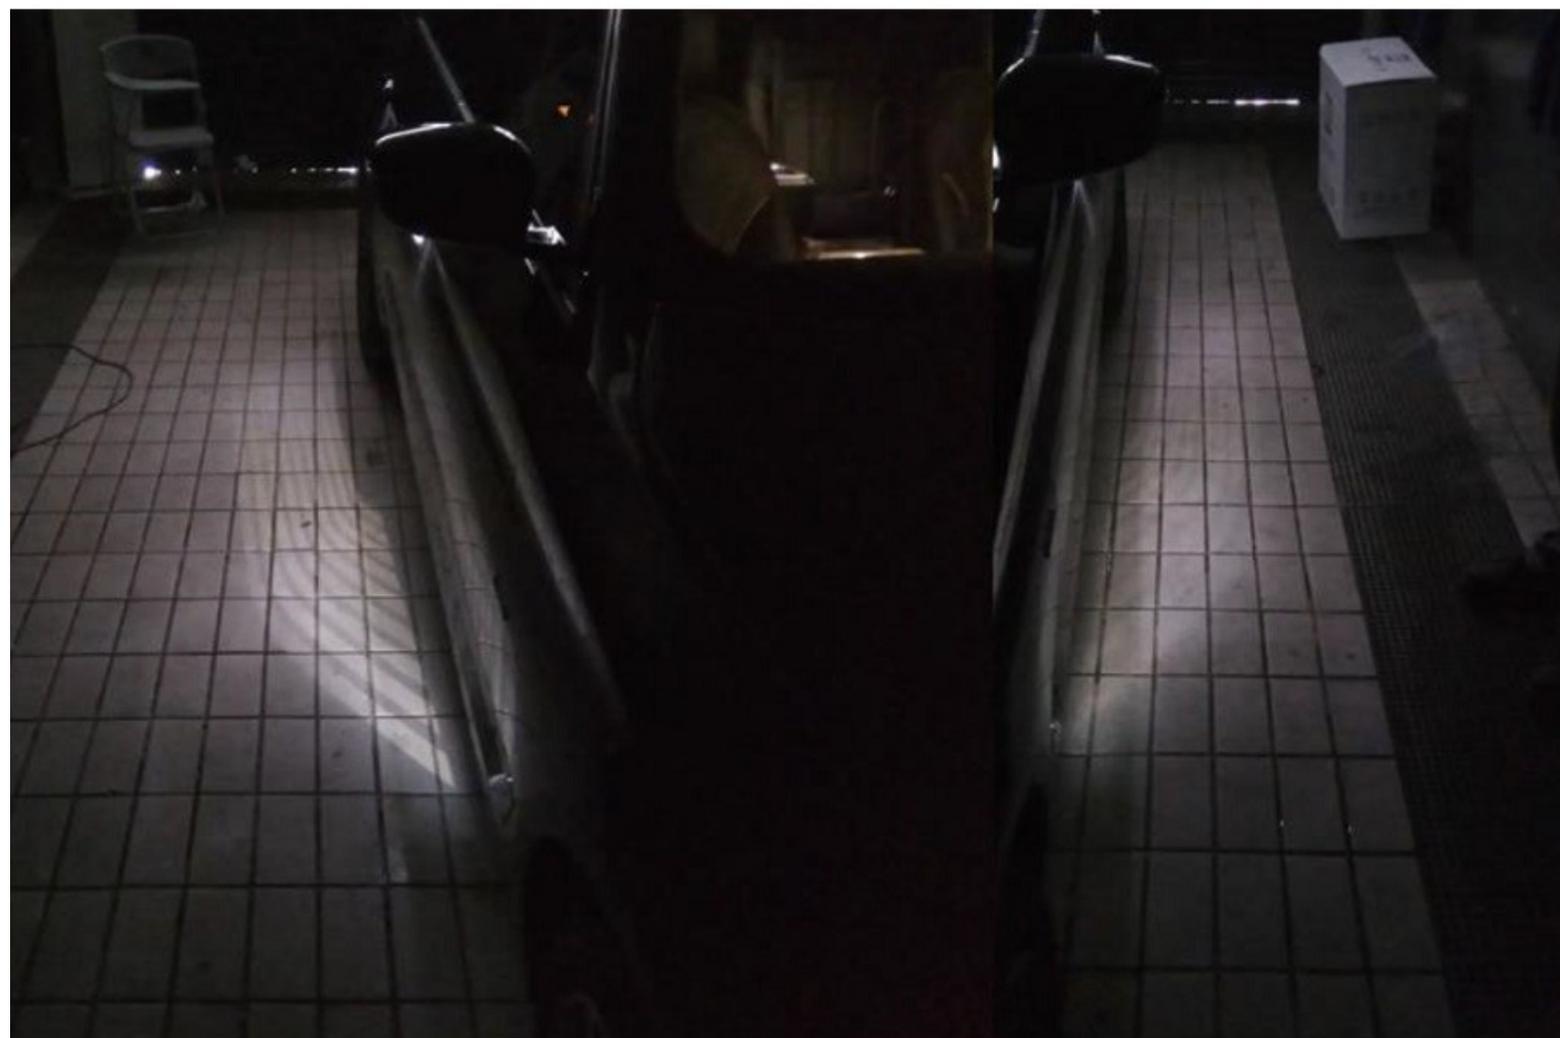
GRUSB6318-05

The light carpet LED lens may be blocked by debris.

Clean the lens of the light carpet module. Replace the light carpet module only if the lens cannot be sufficiently cleaned.

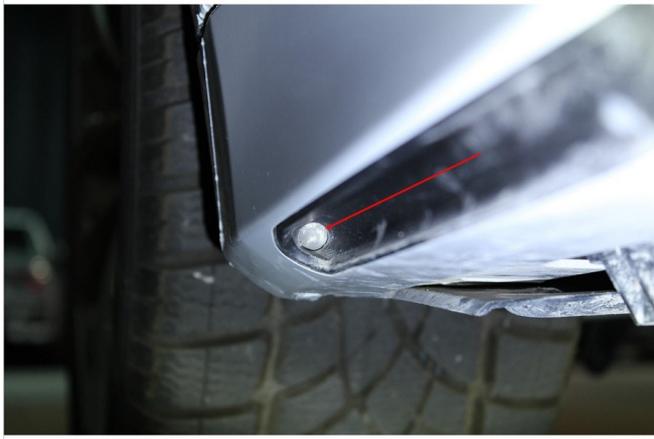
GRUSB6318-02

1. Using a flashlight, inspect the lens of the light carpet module from underneath the vehicle.

Is the lens covered by debris?
