TANK VENTILATION AND MIXTURE CONTROL FAULTS STORED IN THE DME

This Service Information Bulletin (Revision 01) replaces SI B13 04 20 **dated April 2020**.

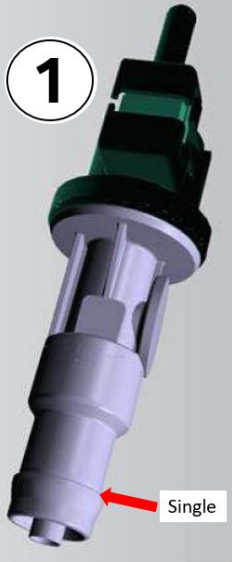
<p>This procedure affects tank ventilation valves with single and dual discharge points.</p> <p>Single (1)</p> <p>Dual (2)</p>
--	--

1. Inspect the discharge point(s) of the tank ventilation valve using a borescope.
