Service Action: Retorque Stiffening Plate Bolts on Front and Rear Axle

112 (i8)

On the front and rear axle stiffening plate bolts, the intended tightening torque may not have been reached during assembly.

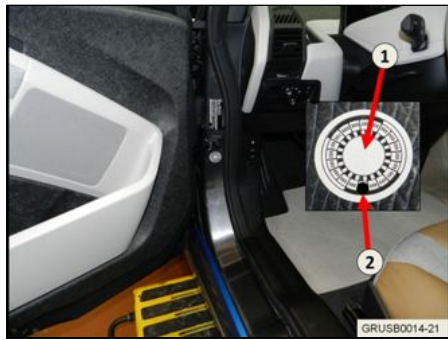
LABEL INSTRUCTIONS

This Service Action has been assigned code number **709**. After the vehicle has been checked and/or corrected, obtain a label (SD 92-453) and:

- A. Emboss your BMW center warranty number in the middle of the label (1);
- B. Punch out code number **709** (2), printed on the label; and
- C. Affix the label to the B-pillar as shown.
