**SEAT FAILS TO INITIALIZE DUE TO MISSING END STOP**

This Service Information Bulletin (Revision 2) replaces SI B52 01 21 **dated June 2021**.

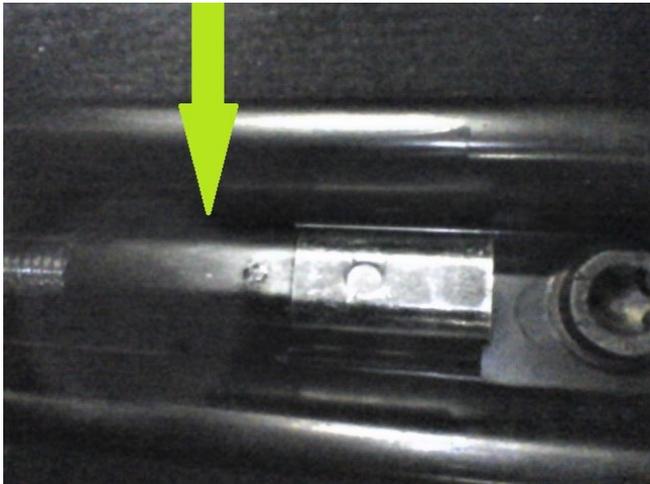
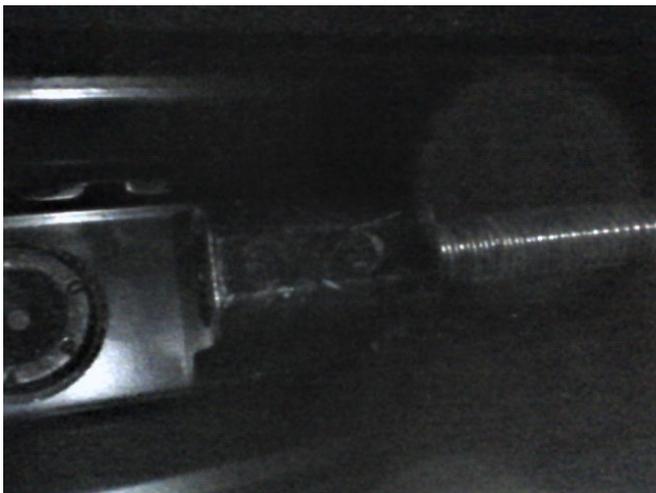
F44 spacer.

Top photo shows end stop (spacer) installed, lower photo shows rail minus the spacer.

1. If this occurs after seat rail replacement, and the new rail **does NOT include the end stop**, then swap the end stop from the original rail.
2. If this occurs after seat rail replacement, and the new rail **does include the end stop**, then confirm the original rail did not have an end stop installed. Remove the end stop from new seat rail.
3. If this occurs after a customer has removed the end stop:
 - Request the customer supply the end stops for reinstallation if still available
 - Order end stop if available separately in ETK, see Parts section below.
 - If the end stop is not available separately in ETK then
 - it may only come with an entire seat rail assembly.
 - contact Parts Technical Support via a TTS TSARA case for support
