THIGH SUPPORT UPHOLSTERY DETACHES FROM SEAT

This Service Information Bulletin (Revision 3) replaces SI B52 10 19 **dated January 2020**.

E-Series	Model Description
G05	X5 Sports Activity Vehicle
G06	X6 Sports Activity Vehicle
G07	X7 Sports Activity Vehicle

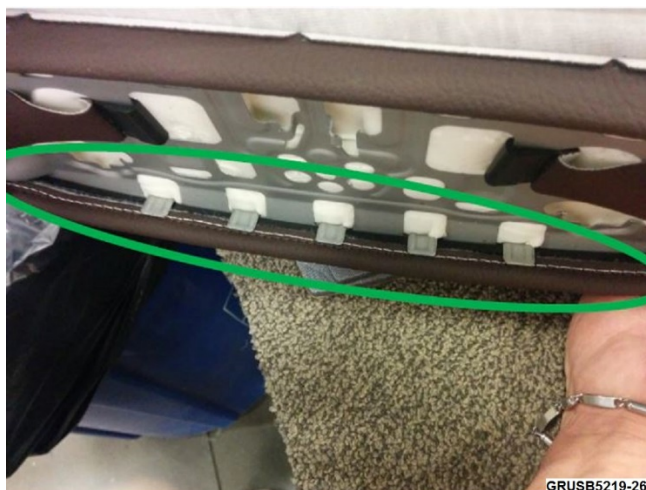
- Clips are firmly pressed against the trim
- No gap exists between the trim and metal clips

Note: Bend the 5 metal clips as necessary.
