**MODEL**

E-Series	Model Description	Production Date	Affected Option Code
F95	X5 M Sports Activity Vehicle (SAV)	From Start of Production	SA <b>534</b> automatic climate control <b>Standard on G05 G06</b> SA <b>4NB</b> 4-zone automatic climate control <b>Std on G07 F95 F96, Option on G05 G06</b> SA <b>4NN</b> 5-zone automatic climate control (Third row) <b>Option on G07</b>
F96	X6 M Sports Activity Coupe (SAC)		
G05	X5 SAV		
G06	X6 SAC		
G07	X7 SAV

The customer states that one of the front or rear climate control zones is unresponsive and either gives too cold or too warm air regardless of IHKA setting.

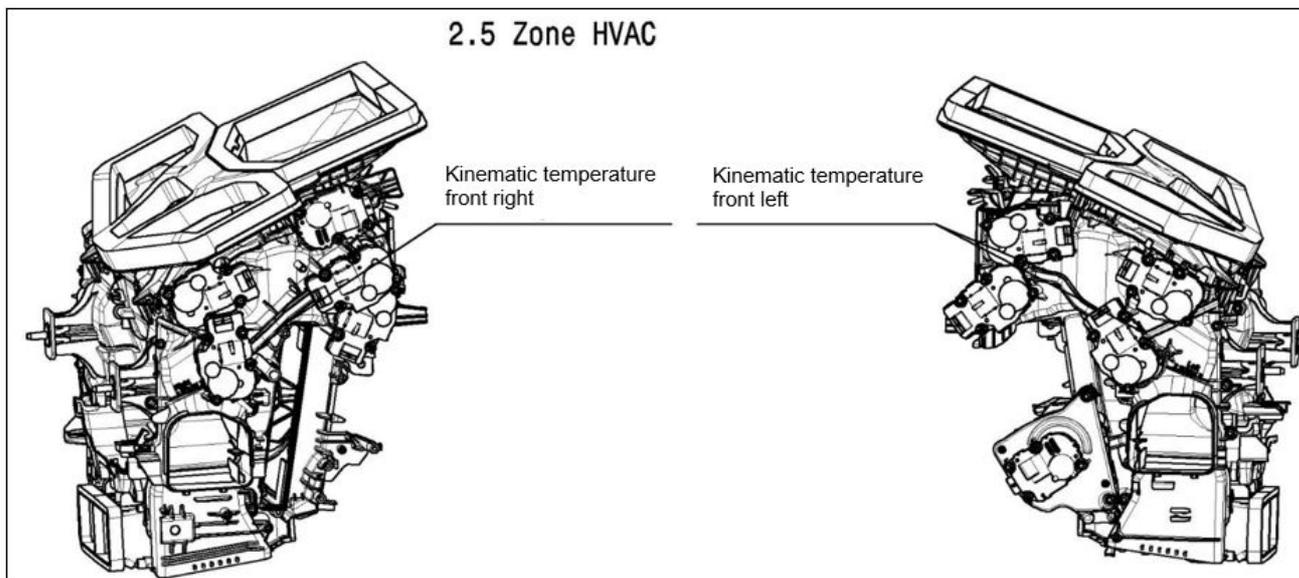
For vehicles equipped with option code **534** automatic climate control:

- A 2.5 zone climate housing is used with 3-piece linkages on both sides

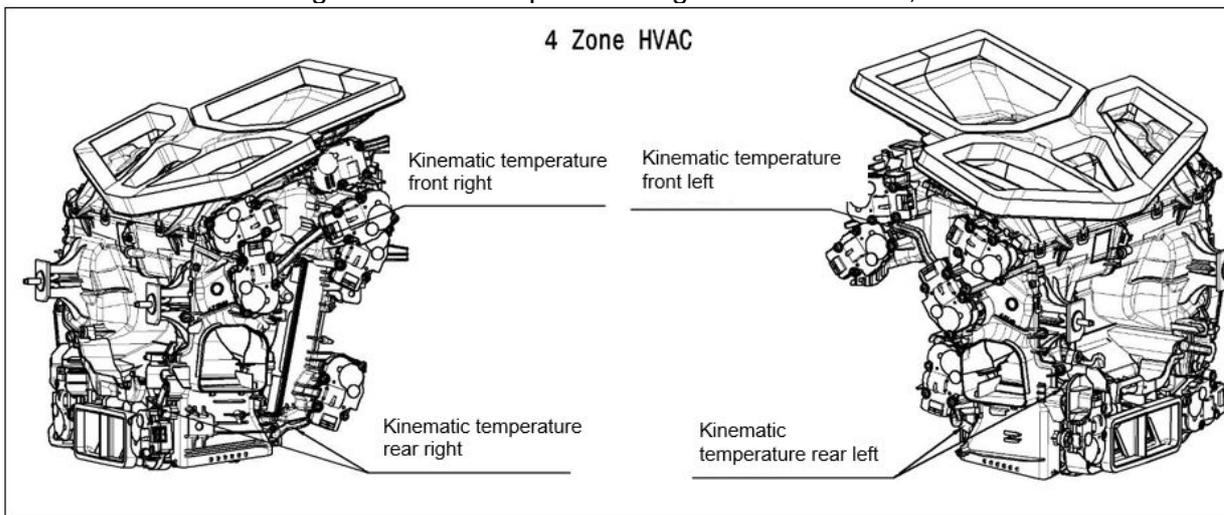
For vehicles equipped with option codes-

- **4NB** 4-zone automatic climate control
- **4NN** 5-zone automatic climate control

A 4-zone climate housing is used with 3-piece linkages on both sides, front and rear.

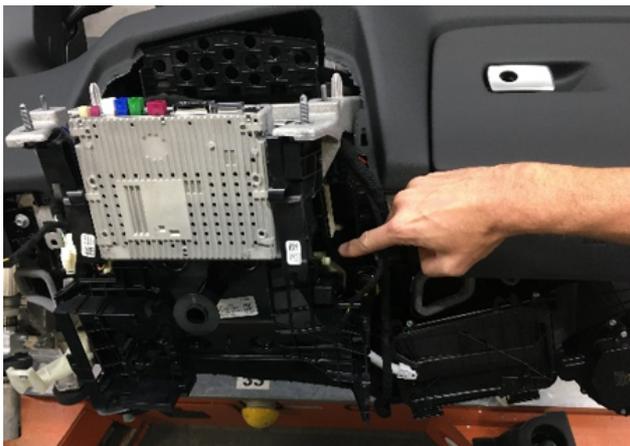
The repair kit contains a 3-piece linkage that fits the rear right temperature blend flap.

The link at the bottom fits into the flap.

For access to this assembly see Premium repair instructions "Replacing controller drive of stratification flap, rear passenger compartment, right **REP-P-6411823**"

**NOTE:** For access to the passenger side rear flap linkage, it is not necessary to remove the center console.

The stepper motor can be accessed by removing the passenger side trim from the center console.
