This Service Information Bulletin (Revision 11) supersedes SI B64 06 13 **dated December 2020**.

MODEL

SITUATION

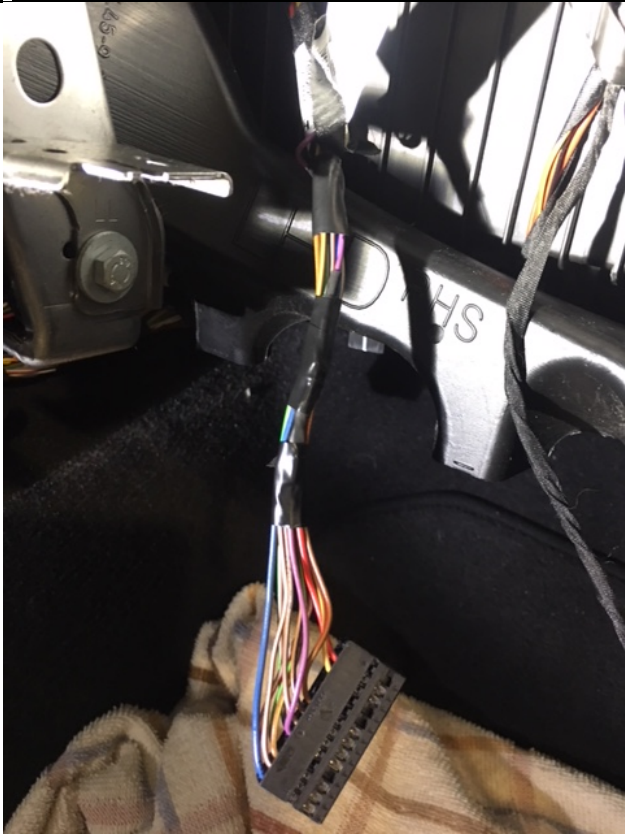
In the rare case, in very high humidity areas, that the evaporator continues to experience freezing after the above countermeasures have been performed, modify the evaporator temperature sensor input by installing an 800-ohm (1/4 watt) resistor in-line between the evaporator temperature sensor and the IHKA control panel.

The resistor must be attached to the harness either with plastic wire-ties or electrical tape.

After reassembly, clear the fault memory.
