WHIRRING NOISE IN VEHICLE HEARD BETWEEN THE SUBWOOFERS WHEN LOUD MUSIC PLAYING

E-Series	Model Description	Production Date
I15	i8 Roadster	From 3/1/2017 to End of Production

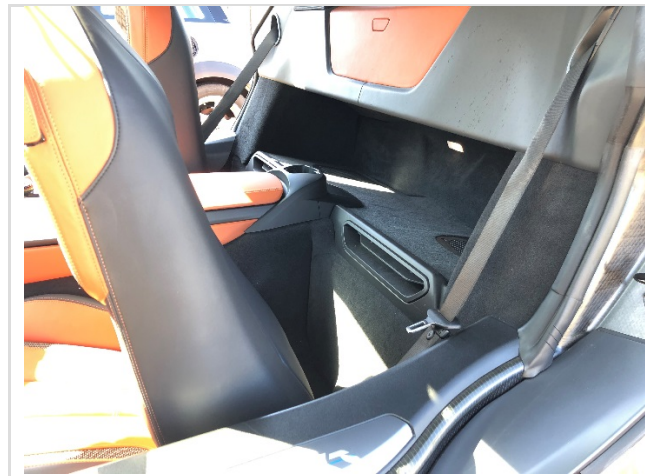
The customer states that there are whirring noises heard from behind the front seats when loud music is playing. It is heard coming from between the two subwoofers, behind the rear cupholder.

Release the safety belt(s) from the belt guide at the side of the seat(s).

Move both seats forward to access the storage area behind the seats.
