| E85 Z4 M Roadster with S54 engine produced 02/10/2006 through 03/20/2006 |

Fault code: 2A1A: Tank Ventilation System, Function is erroneously stored in the DME. The "Service Engine Soon" lamp is illuminated if the same fault code is stored again during the subsequent driving cycle.

DME software calibration error.

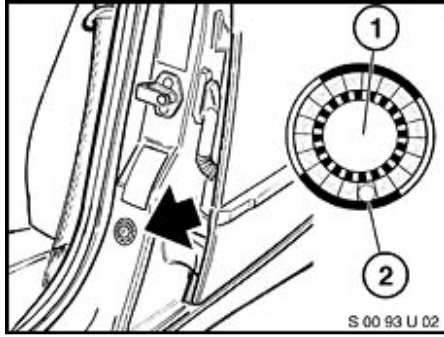
This Service Action has been assigned code number **467**. After the vehicle has been checked, and corrected if necessary, obtain a label (SD 92-295) and:

- emboss your BMW dealer warranty number in the middle of the label (1);
- punch out code number **467** printed on the label and,
- affix the label to the **B** pillar as shown.
