## MODEL

112 (i8)
----------

## SITUATION

If certain faults are stored, the OBD “freeze frame” data is not properly stored.

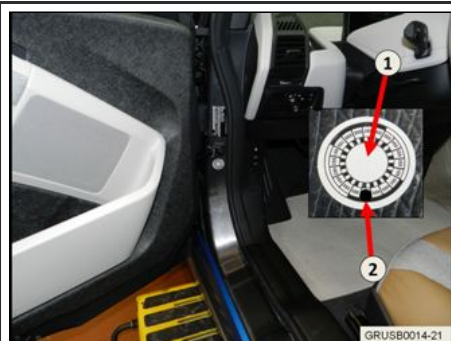
## LABEL INSTRUCTIONS

This Service Action has been assigned code number **702**. After the vehicle has been checked and/or corrected, obtain a label (SD 92-453) and:

- A. Emboss your BMW center warranty number in the middle of the label (1);
- B. Punch out code number **702** (2), printed on the label; and
- C. Affix the label to the A-pillar as shown.
