Service Action: Check Underbody Panel

i12 (i8)

Produced from May 16, 2014 to October 2, 2014

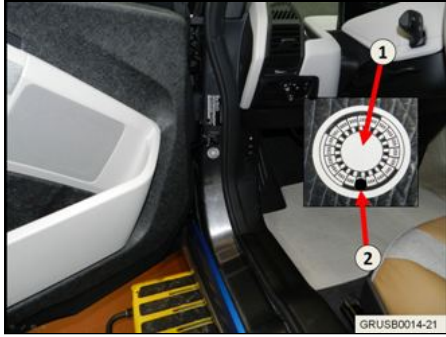
LABEL INSTRUCTIONS

This Service Action has been assigned code number **718**. After the vehicle has been checked and/or corrected, obtain a label (SD 92-453) and:

- A. Emboss your BMW center warranty number in the middle of the label (1);
- B. Punch out code number **718** (2), printed on the label; and
- C. Affix the label to the A-pillar as shown.

First check if a Service Action label with a code number **718** is already attached to the A-pillar.

If a code number **718** has been punched out, the Service Action has already been performed and no further action is necessary.
