This Service Information Bulletin (Revision 6) replaces SI B00 01 18 **dated May 2019**.

MODEL

SITUATION

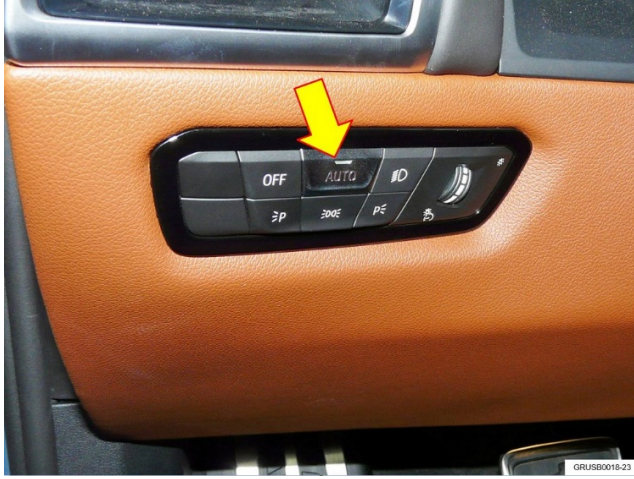
Press the “AUTO” button in the light switch cluster.

Note: 8 Series shown; G20 and G29 are similar.

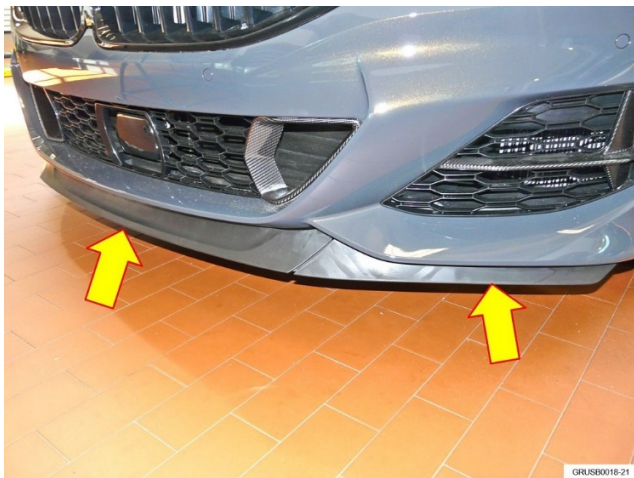
A front bumper 3-piece rubber spoiler is **included in the vehicle’s trunk and must be installed** during QC1. Install it at the bottom of the bumper using the fasteners provided with the vehicle.

For the G14 and G15 only, the front bumper 3-piece rubber spoiler, **included with the vehicle, must be installed** during the QC1.

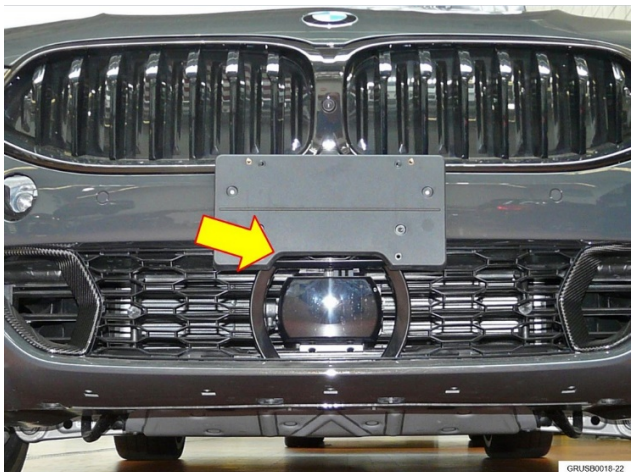
For states that require a front license plate- The 8 Series’ front license plate bracket has an upward cutout (arrow) for additional clearance of the front radar sensor. The bottom edge of a front license plate covers up the cutout area.

This has been tested and confirmed that the sensor is not affected.
