This Service Information Bulletin (Revision 8) replaces SI B00 02 18 **dated July 2019**.

MODEL

F16 (X6 Sports Activity Coupe)	F39 (X2 SAC)	F48 (X1 Sports Activity Vehicle)	F86 (X6 M SAC)
G01 (X3 SAV)	G02 (X4 SAC)	G05 (X5 SAV)	G07 (X7 SAV)

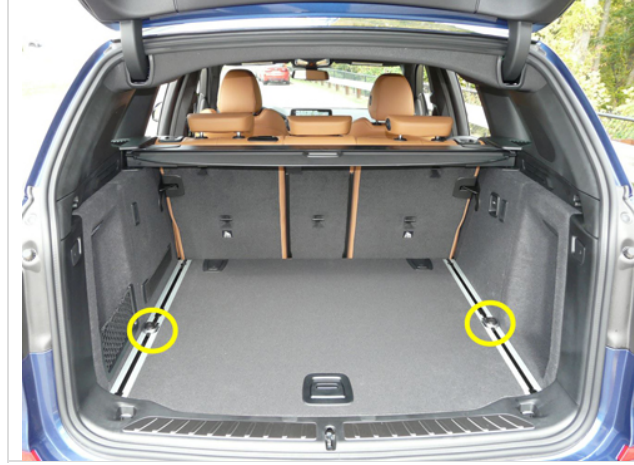
- X3, X4: As of July 16, 2019 the two moveable lashing eyes for the cargo area floor rails are included in the by-pack bag.
 - Install one into each rail (circled)
 - X3 and X4 with optional space saver spare tire (code 300) do not have floor rails nor the lashing eyes
 - Previously they were already installed in the rails during the manufacturing process

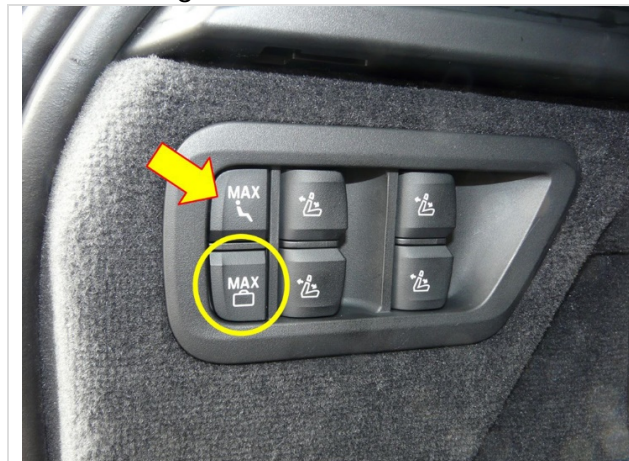
After the initialization via ISTA is complete, briefly confirm proper seat movement:

- Press the "maximum luggage" button at the left cargo area trim panel (circled)
- Observe that the second row captain's chairs start to move slightly forward to prepare for the third row seat backrests folding forward

To avoid waiting for the entire seat movement cycle to be completed-

- Press the "maximum seating space" button (arrow)

When equipped with the Second-Row Captain's Chairs (option code 4U5; aka 6-seater/Executive Lounge Seating), initialize the captain's chair seats using the ISTA service function "Seat Adjustment Standardization".

- Perform while still connected to ISTA, after deactivating transport mode and the customer hand-over inspection
- Select "Rear driver's side standardization", and "Rear passenger's side standardization"
- QC1 Reference Checklist (refer to Attachment 1) has been revised, adding this initialization

Note: Do not attempt to initialize the captain's chair seats using the seat movement switches. There is a risk of the fore/aft movement jamming if a certain seat movement sequence is not followed. The jamming is due to possible misalignment of the seat retention "J-hooks" at the inner seat rails.

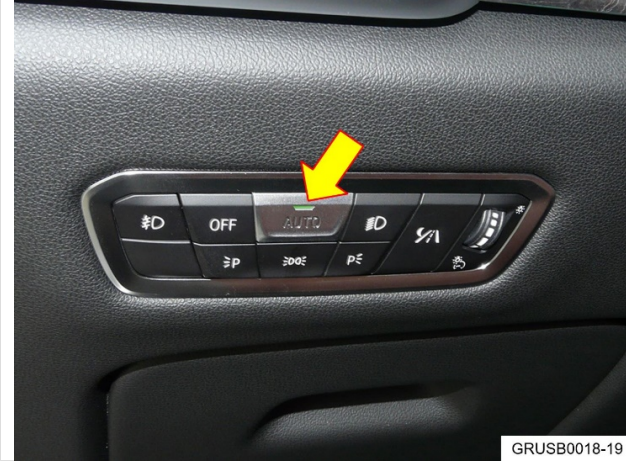
Most QC1 operations are the same as for the G01.

- Press the “AUTO” button in the light switch cluster.

G05 shown; G07 is similar.
