This Service Information Bulletin (Revision 1) replaces SI B00 05 22 **dated April 2022**.

MODEL

| E-Series | Model Description | Production Date |
|---|--|---|
| G26 | i4 Gran Coupe (Battery Electric Vehicle (BEV)) | As of July, 2022 |
| I20 | iX Sports Activity Vehicle (SAV) | As of March, 2022 |

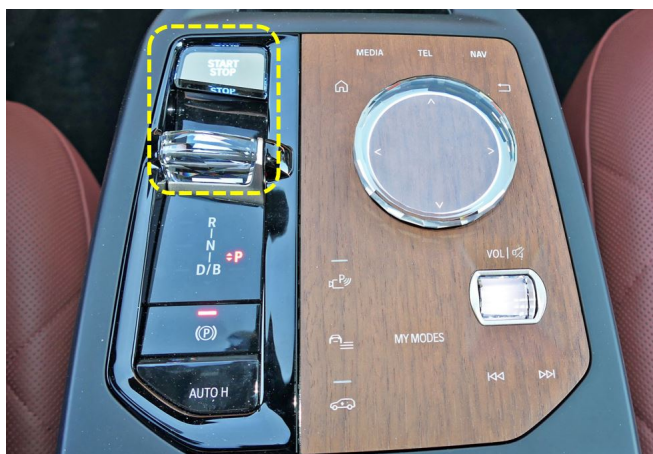
I20 as of 7/2022 production: A “Welcome Sound” (IWS) alerts the driver when either front door is opened.

Additionally, if the Comfort Access is set to “unlock doors when approaching”, the START/STOP button and the gear selector toggle switch (circled) will start to brighten and pulsate a white light.

After the START/STOP switch is pressed to start a drive, the light no longer pulsates, but becomes steady.

After the drive, and after pressing the START/STOP switch to deactivate the motors, the button and gear switch revert back to the pulsating white light.

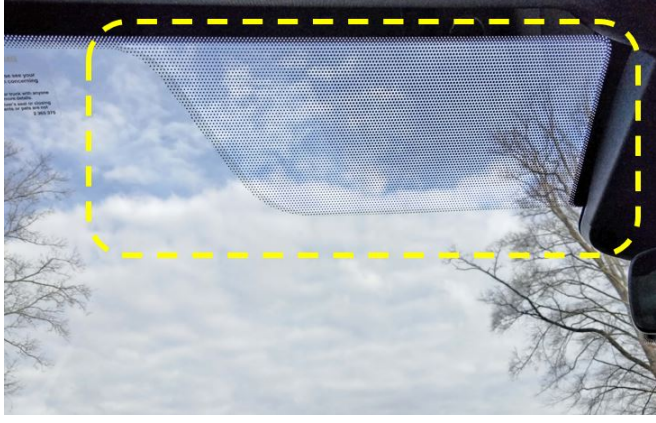
The i20’s windshield and sunroof have a coating to reduce ultraviolet light (UV) transmittal through the glass, which helps to reduce the interior temperature from solar heating. The coating can reduce the effectiveness of driver-mounted devices such as a garage door opener, E-ZPass sensor, radar detector, etc.

Position the device in the “coating-free” areas on the driver’s (shown) or passenger’s side near the headliner.

- Identified by “microdots”
