ENGINE DOES NOT START BELOW FREEZING TEMPERATURES

This Service Information Bulletin (Revision 1) replaces SI B12 03 19 **dated February 2019**.

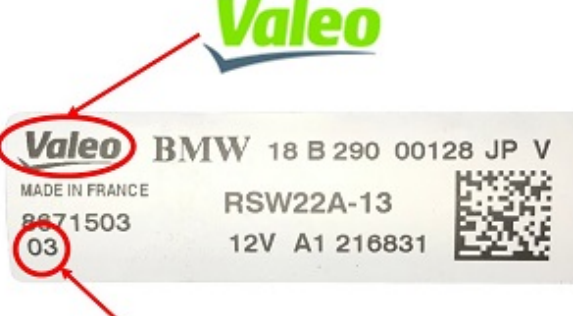
<p style="text-align: center;">Valeo</p>

<p style="text-align: center;">AI Number</p>	<ol style="list-style-type: none"> 2. Check which starter motor is installed: <ul style="list-style-type: none"> • Valeo label shown to the left. • If the original change index is as indicated below, replace the starter • Refer to Repair Instructions 12 41 020 "Removing and installing/replacing the starter motor"
--	---

Engine:	Original starter P/N:	Affected original change index:
B46D	12 41 8 671 503	Thru and including AI03
B46D	12 41 8 671 504	Thru and including AI02
B46D	12 41 8 588 898	Thru and including AI07

Replacement starter P/N (confirm via ETK):	Change index with starter revisions:
12 41 8 693 976	As of AI04
12 41 8 693 977	As of AI03
12 41 8 588 902	As of AI08
