This Service Information bulletin supersedes SI B33 04 09 dated **October 2008**.

E82 and E88 (1 Series), all models	E85 and E86 (Z4), all models	E60 and E61 (5 Series), all models	E63 and E64 (6 Series), all models
E65 and E66 (7 Series), all models	E90, E91, E92 and E93 (3 Series), all models

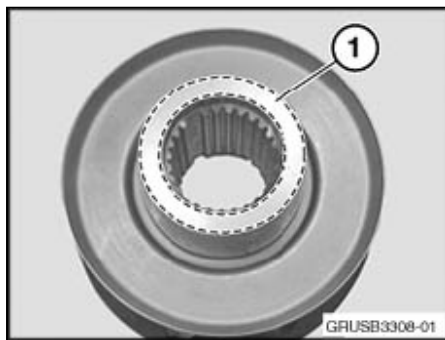
Apply lubricant **UPDATE!** P/N 83 23 0 443 864 on the input flange mating surface (1), as described in the illustration.

Remove the differential drive flange in accordance with Repair Instruction RA 33 11 021.

Before complete reassembly, replace the input flange seal and collar nut retaining plate as described in RA 33 01 021. Refer to the EPC for correct part numbers, based on model.
