This Service Information bulletin supersedes SI 34 07 15 dated December 2015.

i12 (i8)
----------

BMW AG is conducting a Voluntary Safety Recall involving Dynamic Stability Control (DSC) Hydraulic Unit System in certain i8 (I12). Approximately 16 vehicles may be affected.

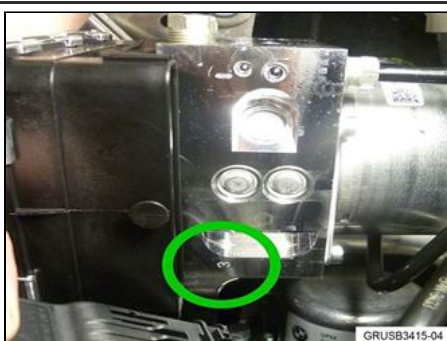
1. Interrupt the voltage to the 12 V battery; see Repair Instructions **REP 61 20 908**.
2. Remove and refit the upper air duct; see Repair Instructions REP 51 64 055.
3. Pull out the connector on the DSC's hydraulic unit.

4. Check the number stamp on the pump block (where shown):

**Is the pump block stamped with the number 2?**

YES- go to Step 5.

NO- No further measures are necessary; reassemble the vehicle.

5. 5. Replace the DSC hydraulic unit; see Repair Instructions **REP 34 51 527**.
