E-Series	Model Description	Affected Option Code
G05	X5 Sports Activity Vehicle (SAV)	Equipped with the standard equipment second row 60/40 seats (7 passenger)
G07	X7 SAV

There is a visible hole in the leather of the 2nd row of seats. The hole is located on the side lock bolt of the left rear seat backrest.

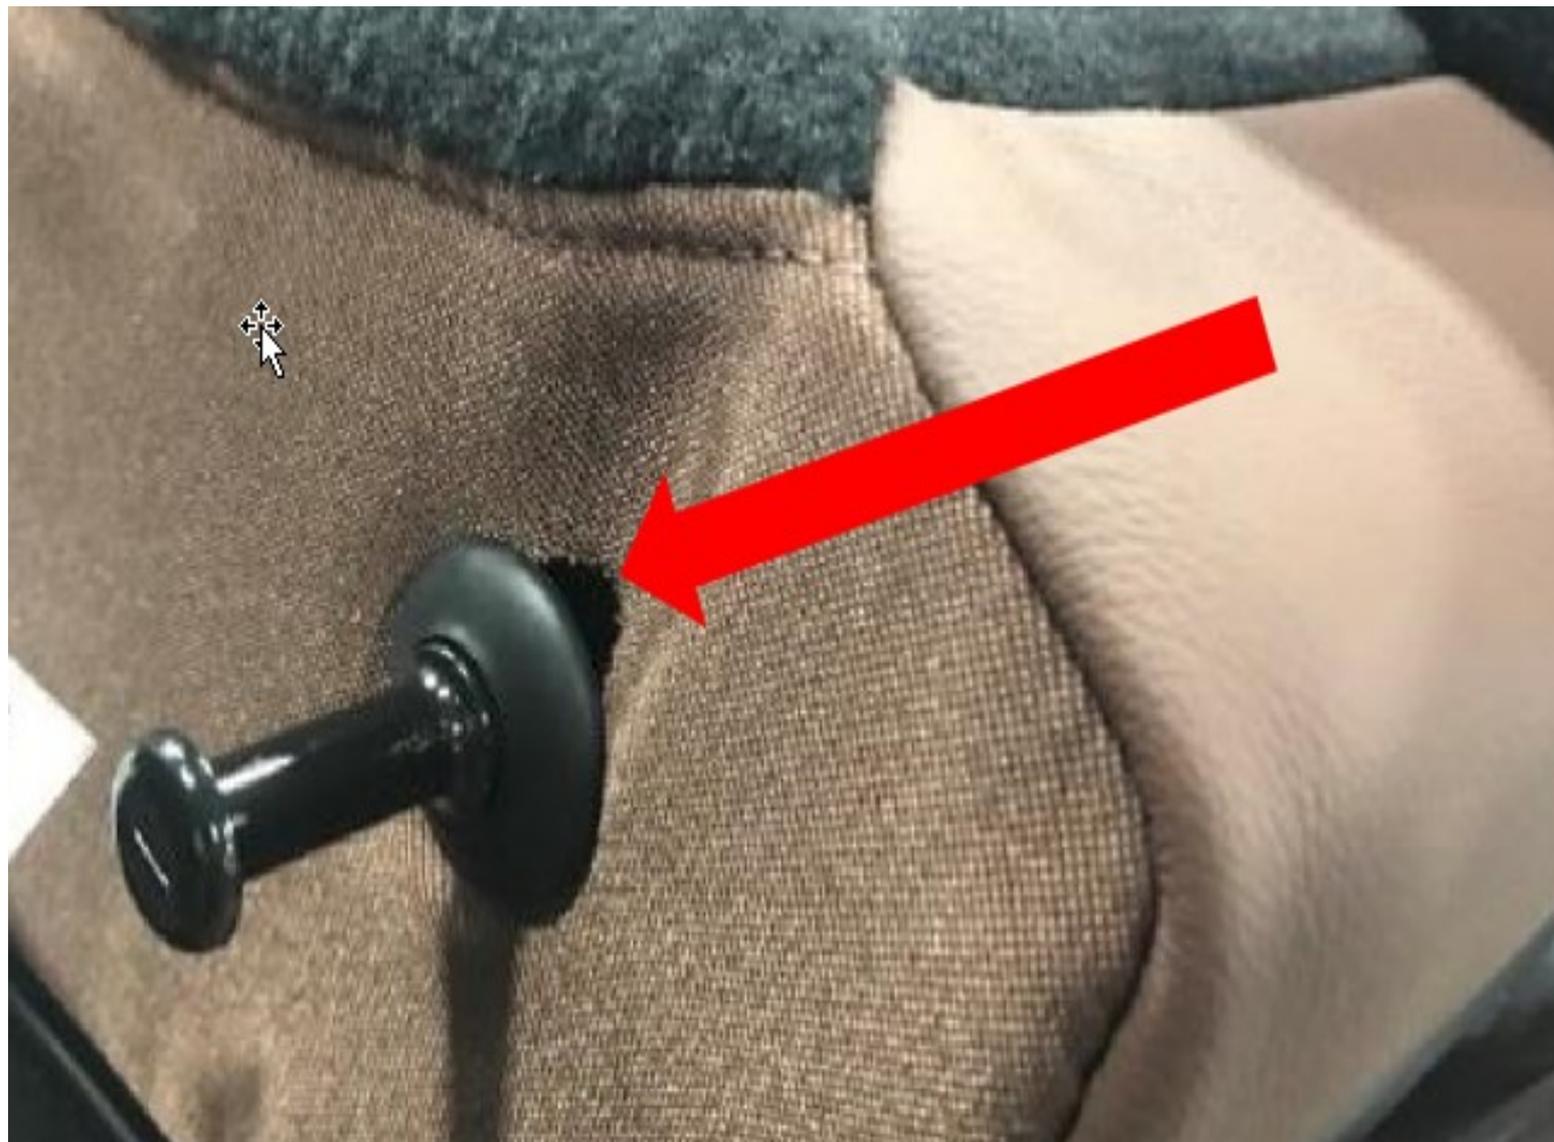
The fault pattern is only visible when the rear seat backrest is folded down.

The hole in the seat cover is slightly larger than specified (2nd row of seats).

Add a larger diameter rubber grommet behind the current one to cover the hole.

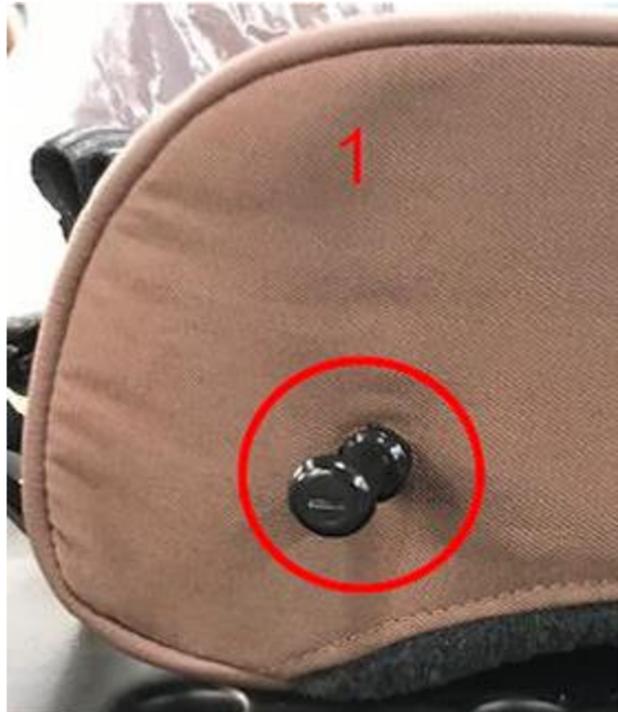
Remove existing cover of center lock bolt (grommet 7444288)
--	---

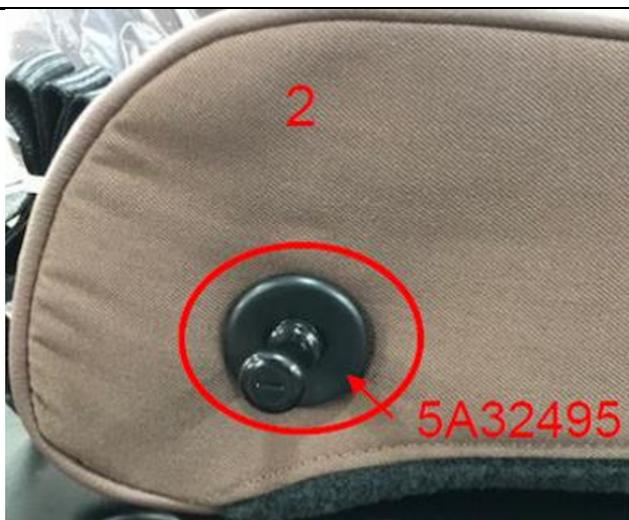
Pull it off the lock bolt.

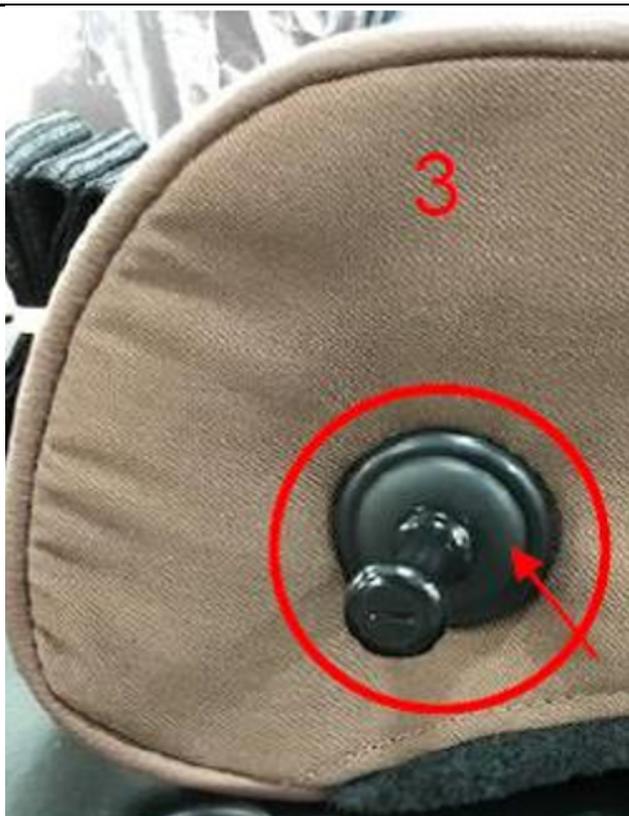
Install cover plate (P/N 52 20 5 A32 495) on the lock bolt.

Install the original cover of center lock bolt.

Ensure that the cover plate and the cover of the lock bolt are firmly attached and are tight to the leather.

Ensure grommets are behind the metal groove of the lock bolt.
