MODEL

I01 (i3 and i3 REx)	I12 (i8)	Vehicles produced from 12/16/13 to 10/15/14
---------------------	----------	---

SITUATION

The vehicle cannot be put into drive readiness or the high voltage system could automatically deactivate during driving.

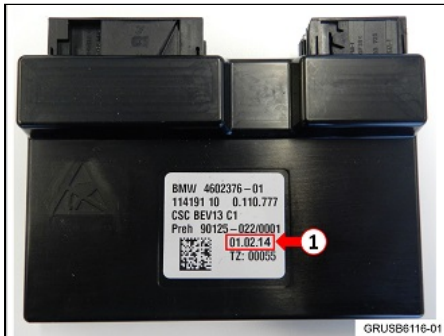
2. Check the production date on the diagnosed CSC (1) to see if it falls within the following production period:

I01 - 12.13.13 to 09.22.14

I12 - 01.20.14 to 04.30.14

Does the production date on the affected CSC(s) fall within the range specified above?

YES- ignore the instructions of the test plan and **replace all CSC's** per repair instructions:

I01 - 61 27 540 - Removing and installing/ replacing cell supervision circuit.

I12 - 61 27 540 - Removing and installing/ replacing cell supervision circuit (top) & 61 27 542 - Removing and installing/replacing cell supervision circuit (bottom)
