RECALL 18E-092: CHECK THE BMW TURBOCORD PORTABLE EV CHARGER CABLE

This Service Information Bulletin (Revision 1) replaces SI B61 18 18 **dated November 2018**.

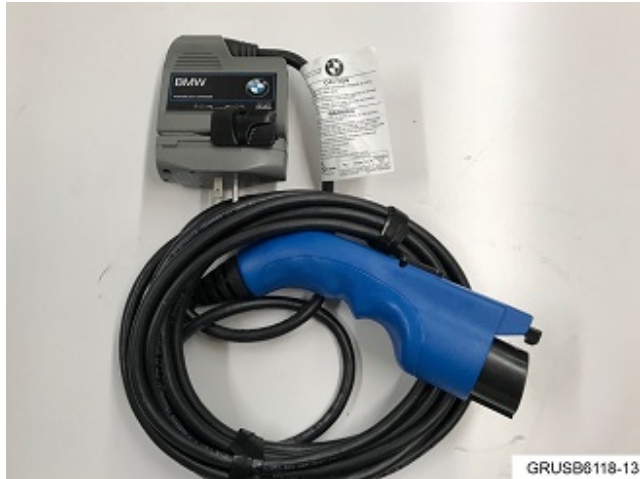
The BMW branded accessory TurboCord Portable EV Charger (110/240V)

Locations of the Product Serial Number

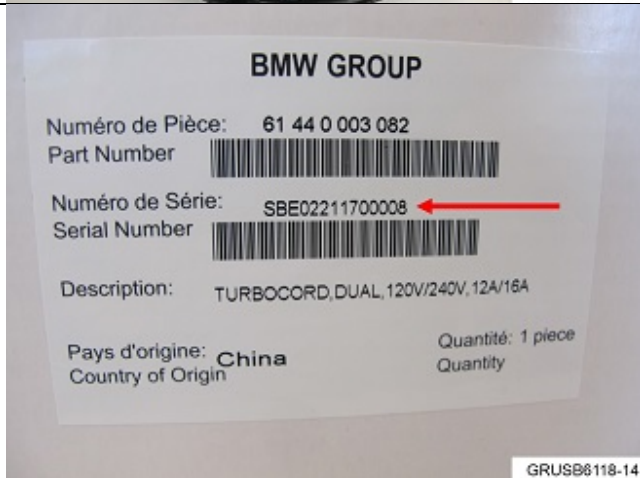
The location of the serial number on the TurboCord Portable EV Charger cable's shipping box is on the product label

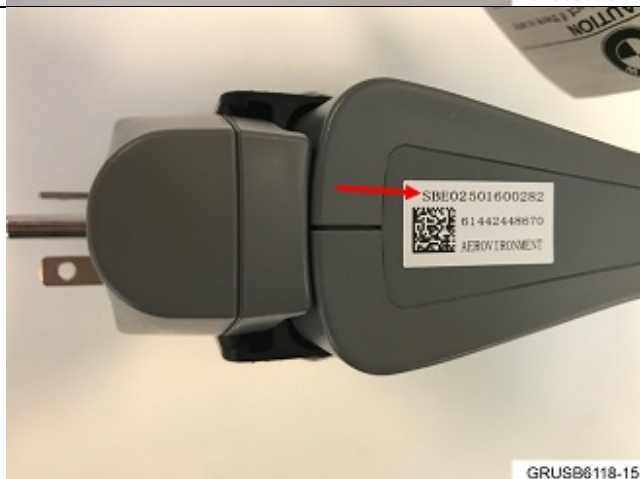
The location of the serial number on the TurboCord EV charger's body plug.
