RECALL 20V-516: HEADLAMP ADJUSTMENT PLUGS

E-Series	Model Description	Production Date
G29	Z4 Roadster	February 7, 2018 – June 5, 2019

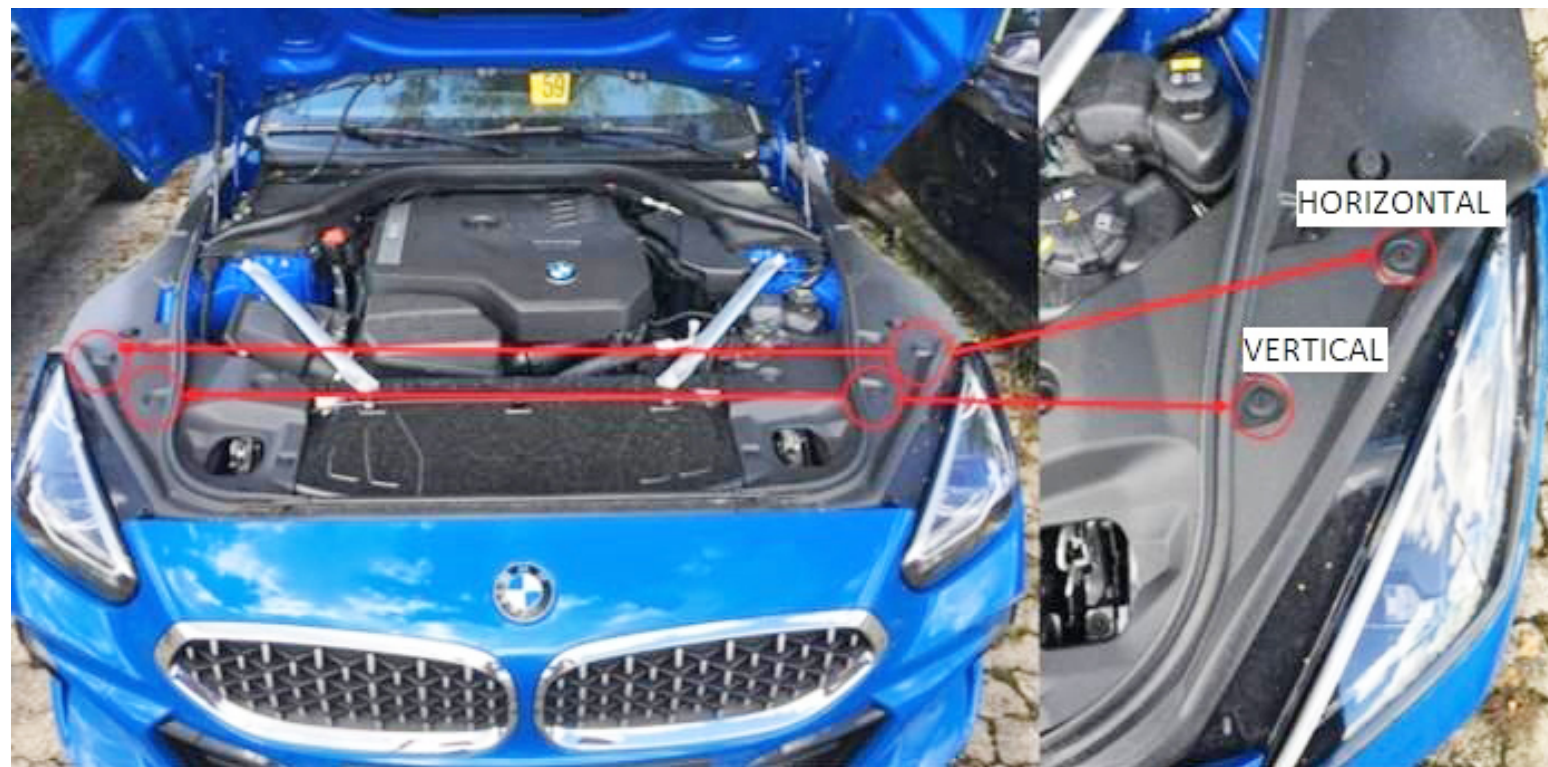
1. Refer to the photo below to familiarize yourself with which adjuster is horizontal, and which is vertical:

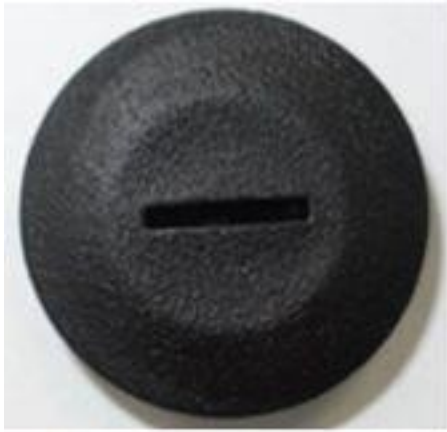
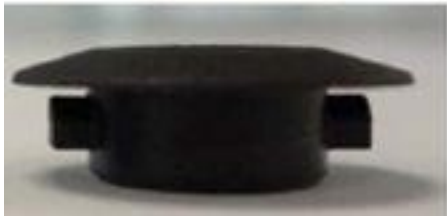
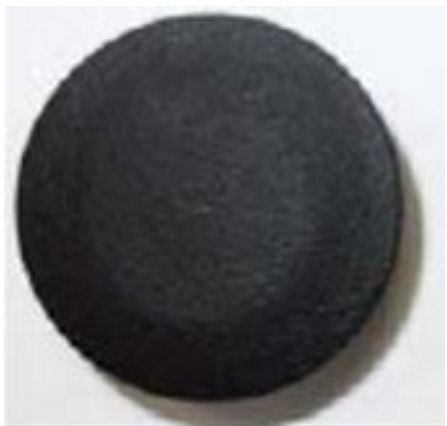
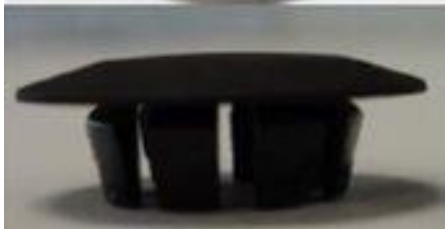
2. Inspect the **vertical** adjustment plugs first.
Do both plugs have a slot as shown below?

3. Inspect the **horizontal** adjustment plugs. Are both plugs smooth without a slot as shown below?

Yes: Continue to step 3.

No: Install plugs with slot and continue to step 3.

Yes: No further correction is needed.

No: Install smooth plugs without a slot.

Note: The plugs can be swapped, and parts will NOT ALWAYS be required. It is possible to swap the plugs to their correct locations.

- Always ensure that horizontal adjustment plugs are smooth
- Always ensure that vertical adjustment plugs are slotted
- Only replace plugs if they are damaged during removal, or when swapping from one adjuster to another will not be sufficient in meeting the criteria above.
